#1 1234 Deadend St.

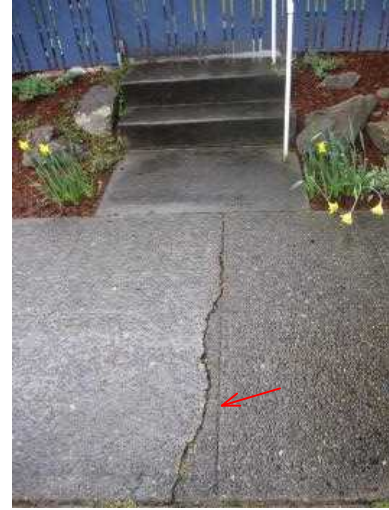
#2 Minor settling and crack in front walkway

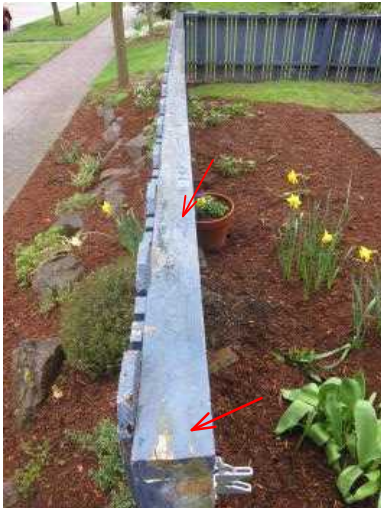
#3 Fence system has minor rot and peeling paint.

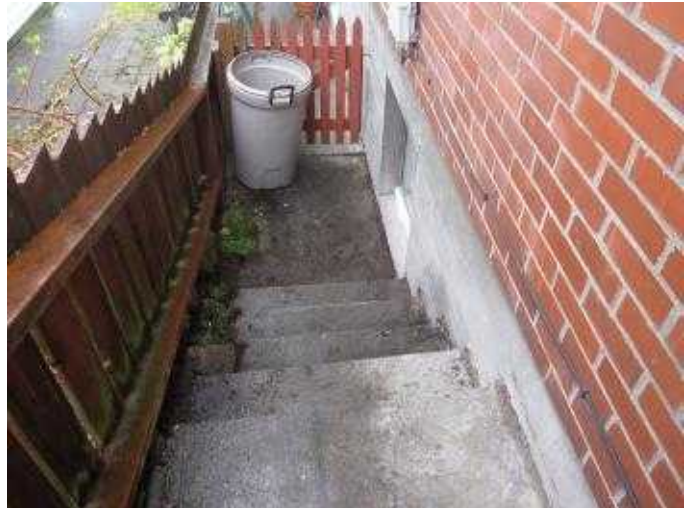
#4 No handrail on North steps.

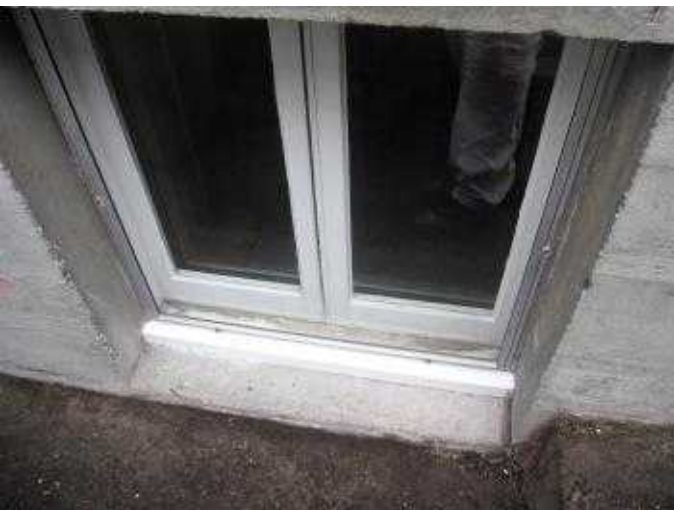
#5 Storm window on North basement window should be tempered. (safety)

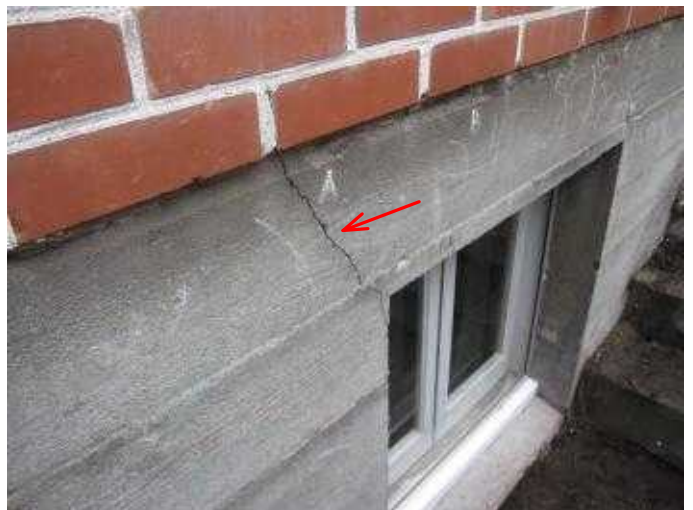
#6 Minor settling crack in foundation on North side. Should be sealed.

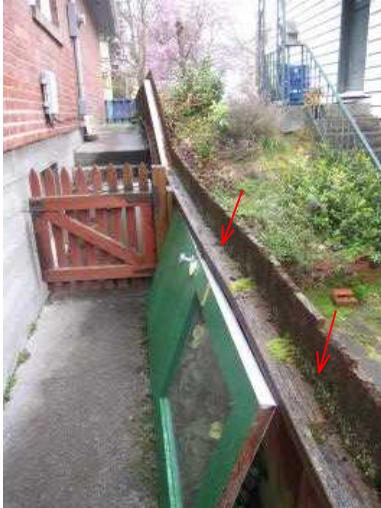
#7 Fence system shows signs of rot.

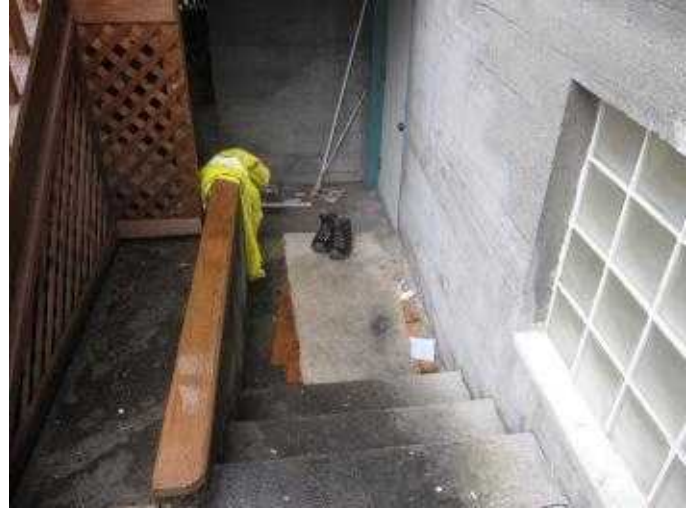
#8 No handrail on steps leading to basement.

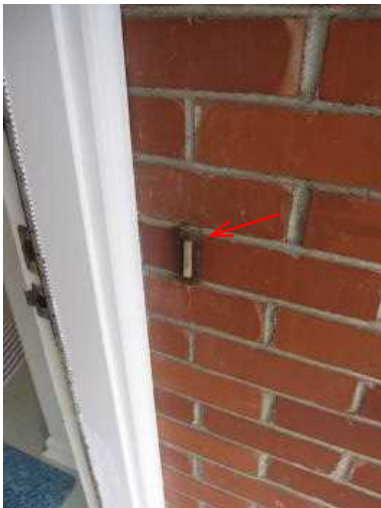
#9 Rear doorbell non-functioning.

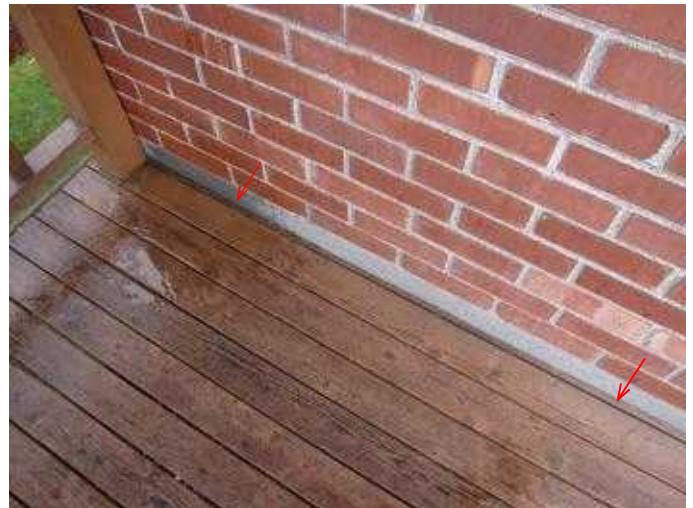
#10 Flashing should be installed at deck to house junction.

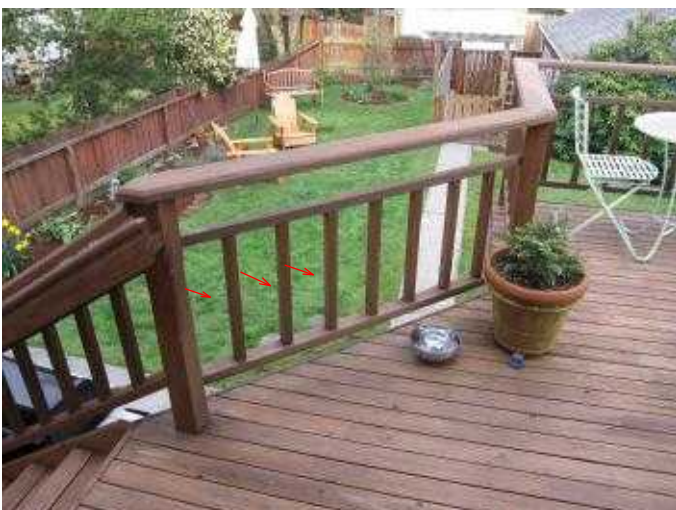
#11 Balluster spacing too wide. (safety)

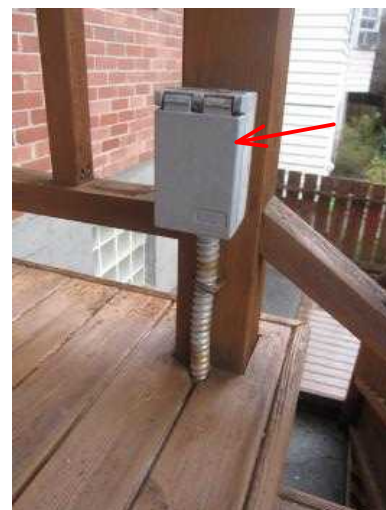
#12 GFCI outlet on deck not tripping when tested.

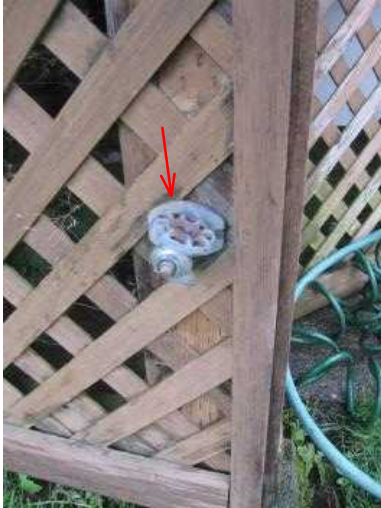
#13 Abandoned hose bib no longer functional.

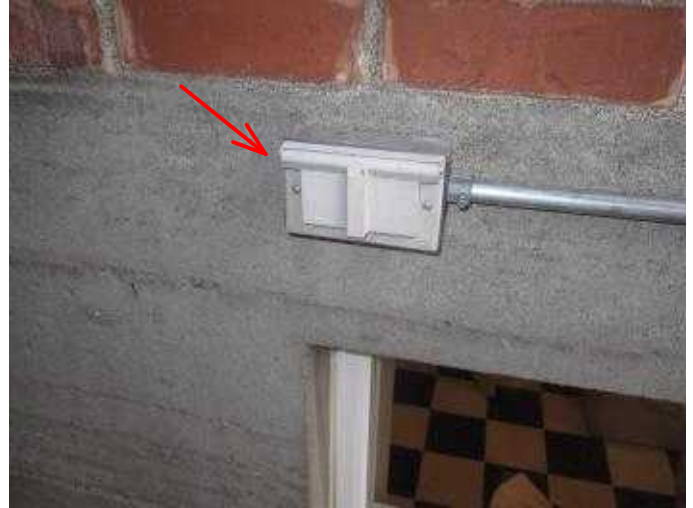
#14 GFCI outlet on South exterior no tripping when tested.

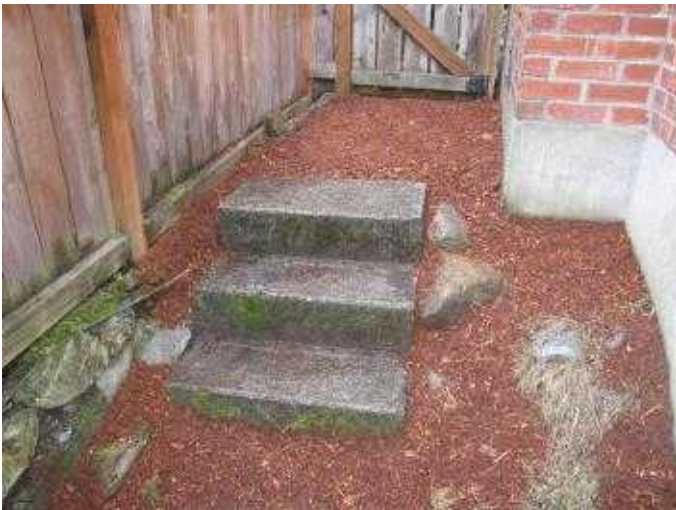
#15 No handrail on South steps.

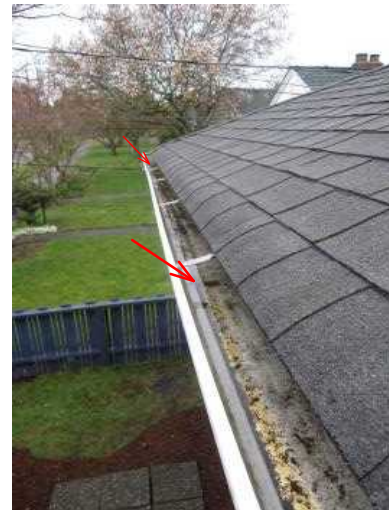
#16 Minor pooling of water in gutter system.

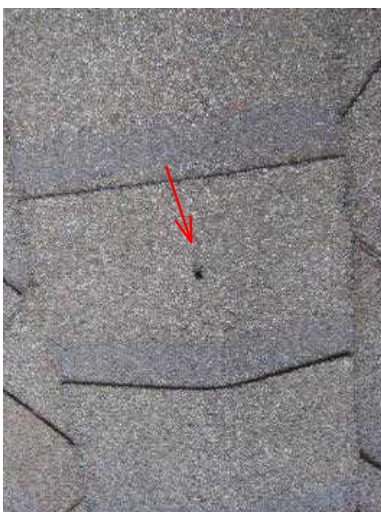
#17 Nail hole in roof should be sealed.

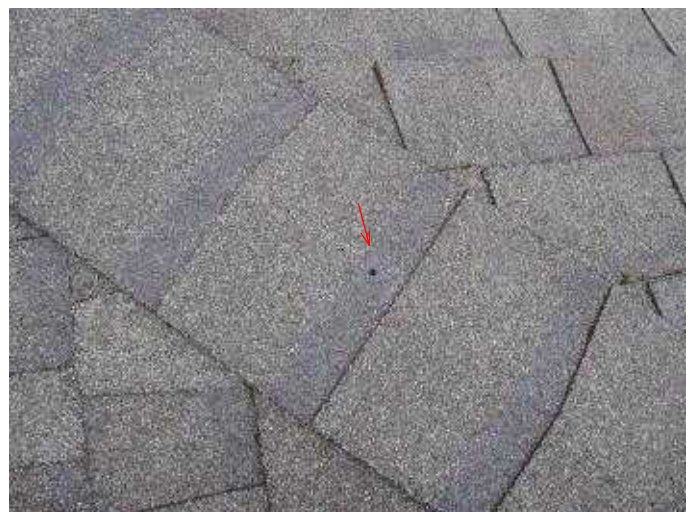
#18 Nail hole in roof should be sealed.

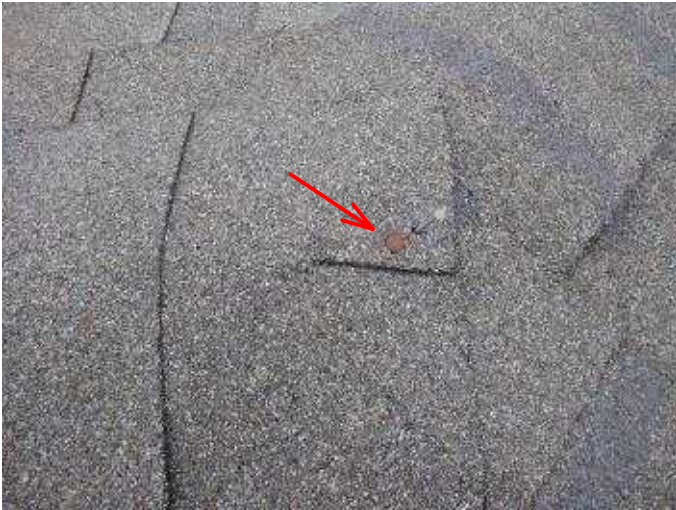
#19 Exposed roofing nail should be sealed.

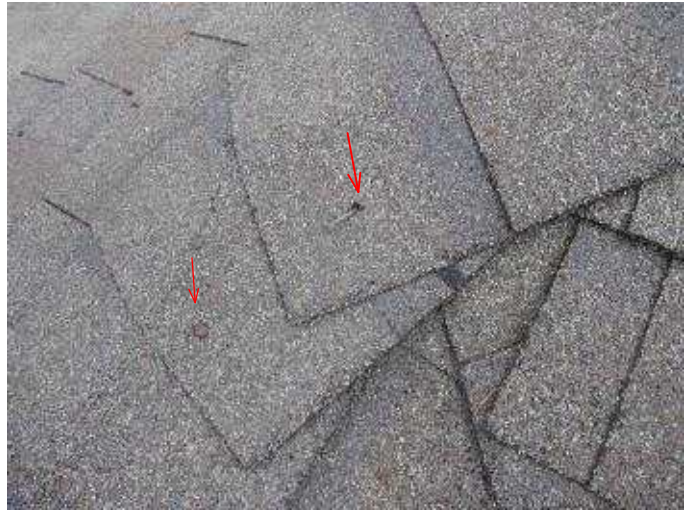
#20 Exposed roofing nail and protruding nail should be sealed.

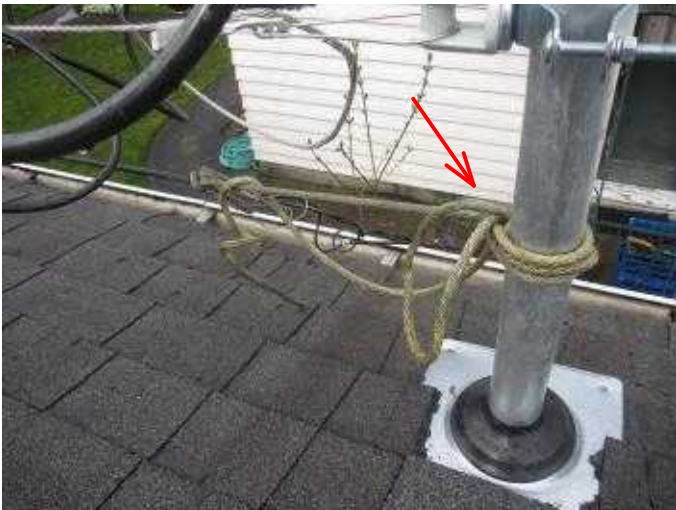
#21 Telephone lines should be permanently secured to mast.

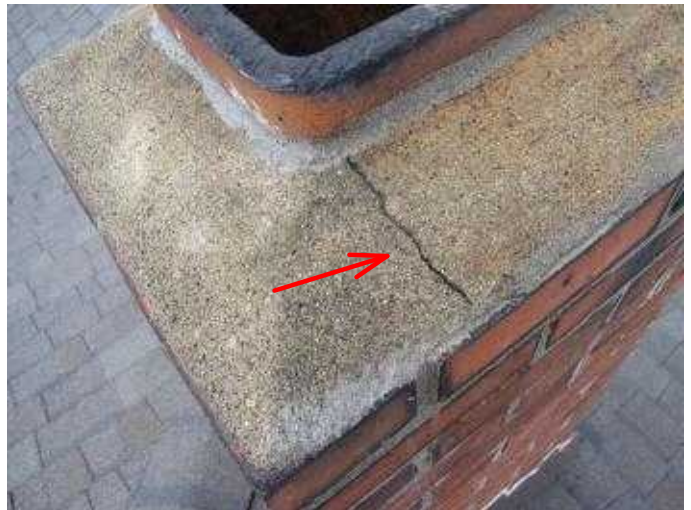
#22 Crack in North chimney crown should be sealed.

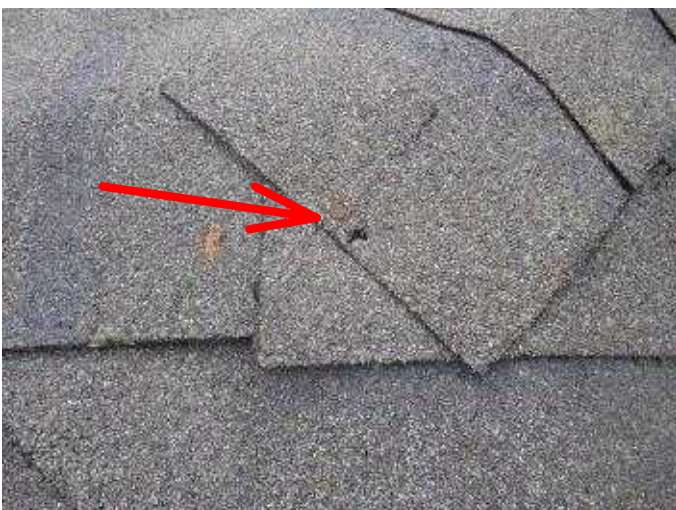
#23 Exposed roofing nail and hole should be sealed.

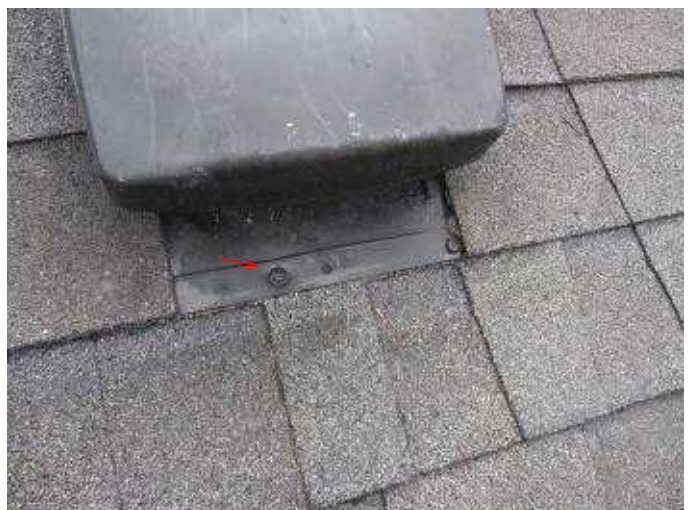
#24 Nail heads should be sealed.

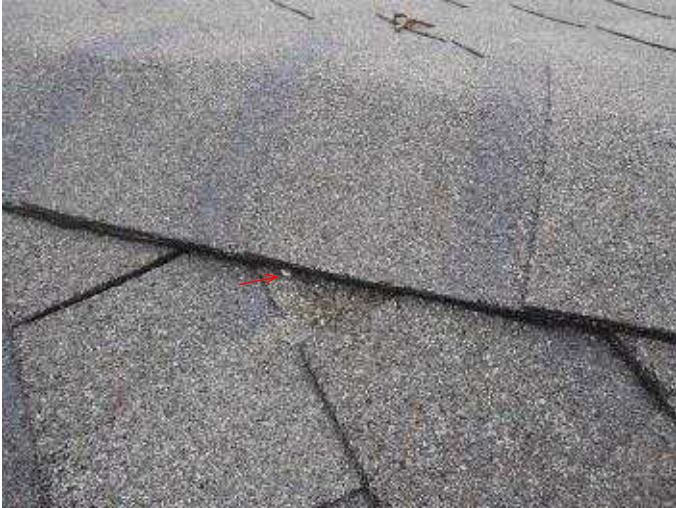
#25 Nail heads should be sealed.

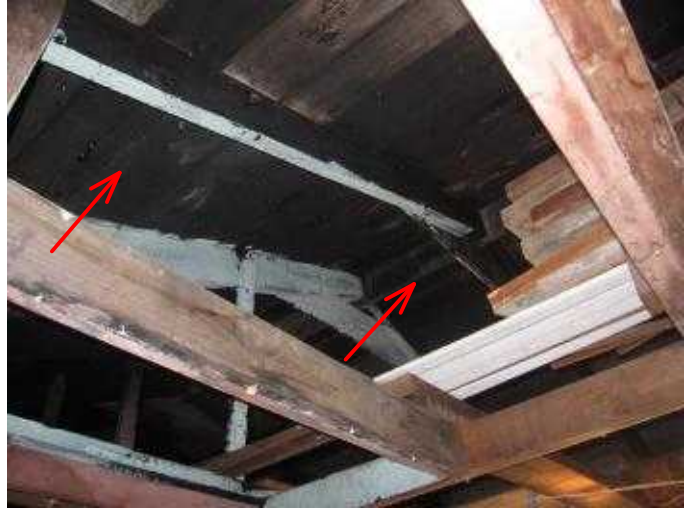
#26 Signs of previous fire in detached garage.

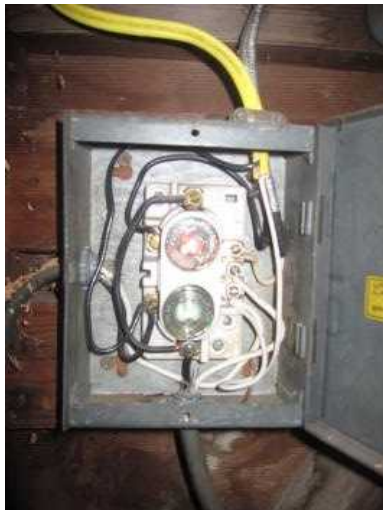
#27 Knob and tube junction box should be upgraded in garage.

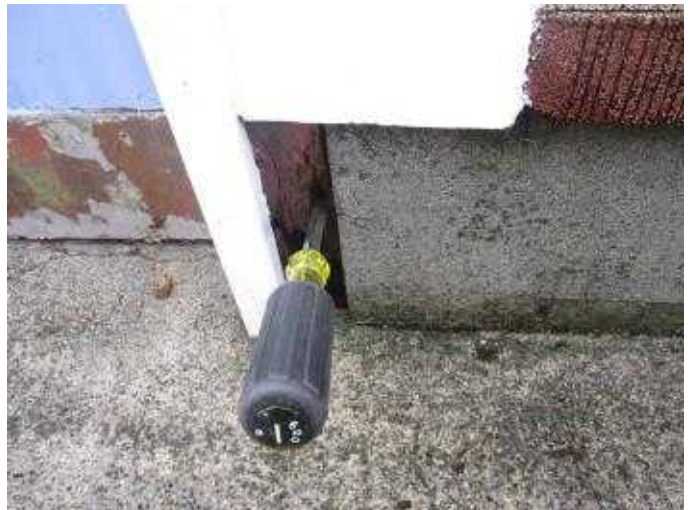
#28 Moderate rot in garage side door jamb.

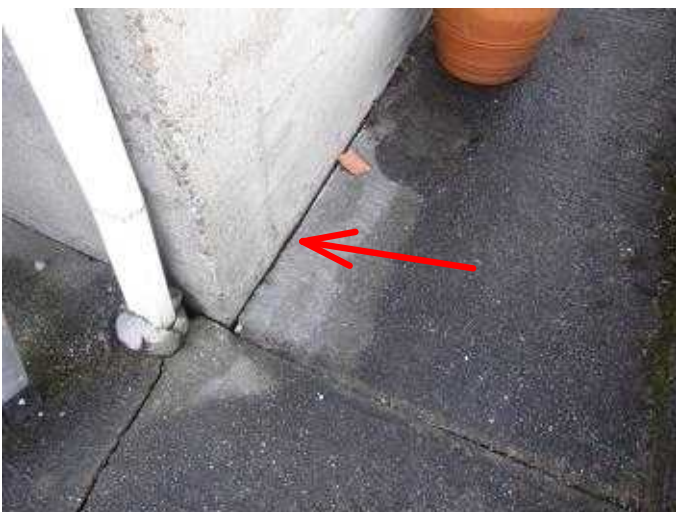
#29 Crack should be sealed where walkway meets foundation.

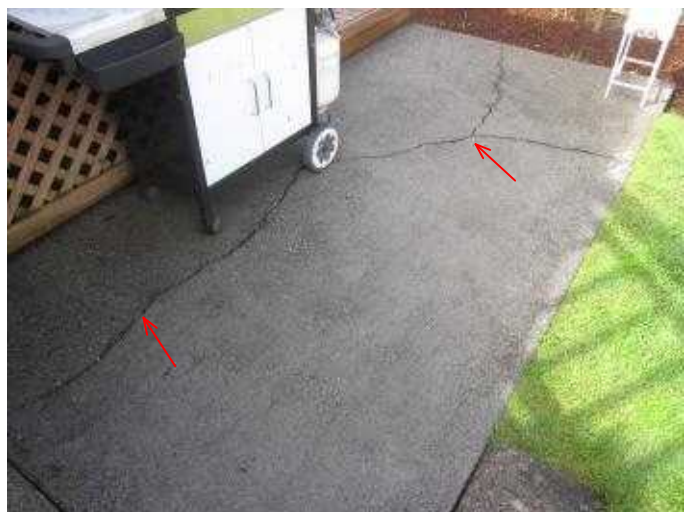
#30 Moderate cracking in patio slab.

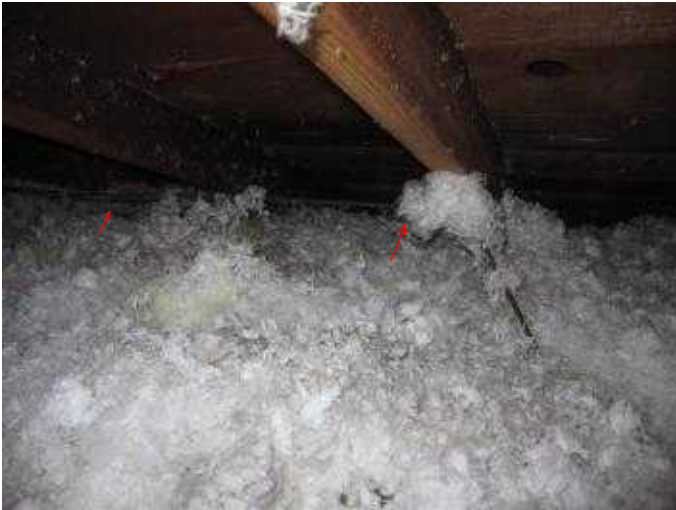
#31 Original knob and tube present in attic and buried in insulation.

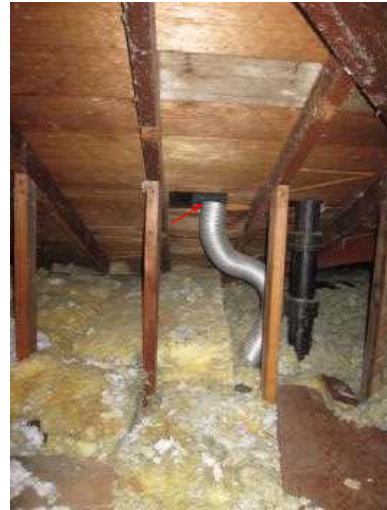
#32 Bathroom vent duct should be secured to outside.

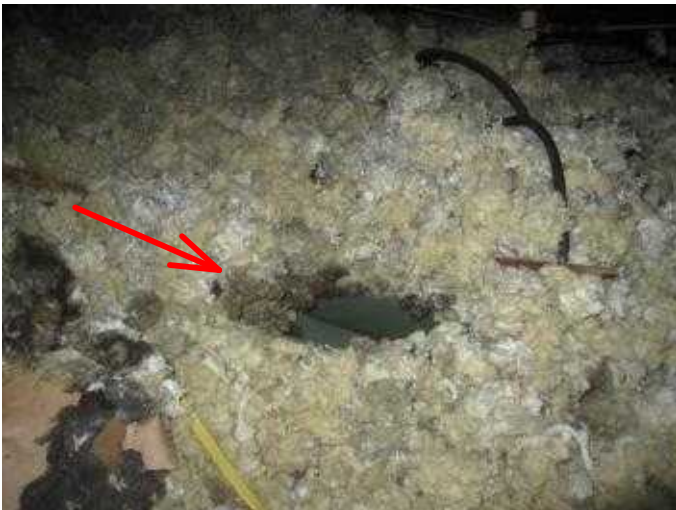
#33 Kitchen exhaust fan vents directly into attic.

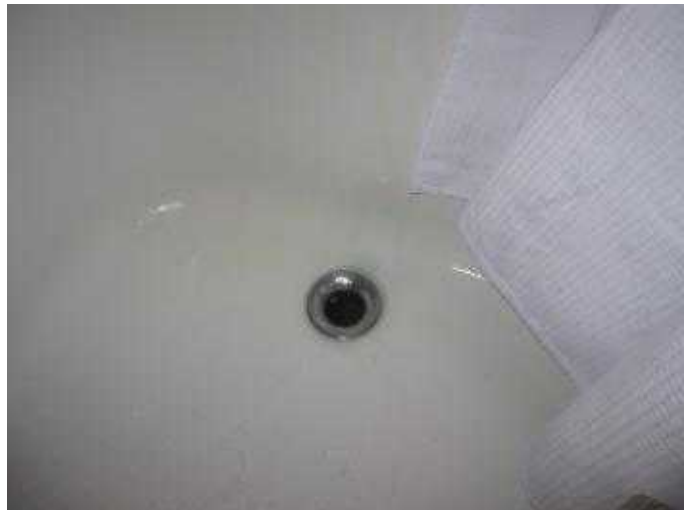
#34 Upstairs bathtub missing stopper.

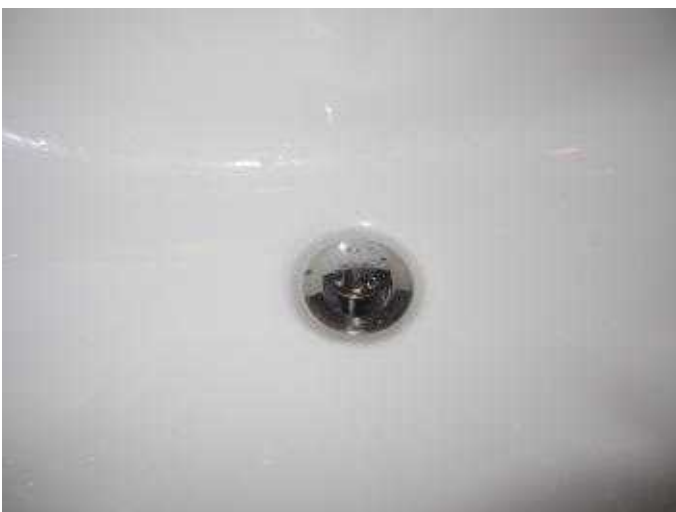
#35 Upstairs sink stopper non-functioning.

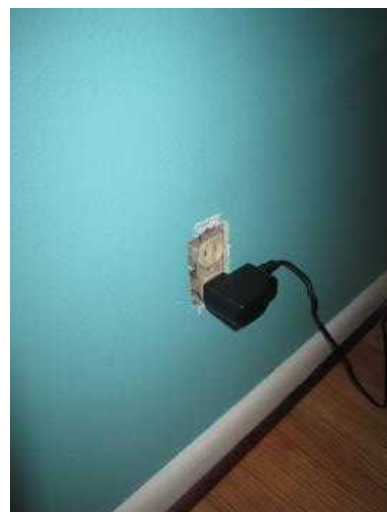
#36 Missing cover plate.

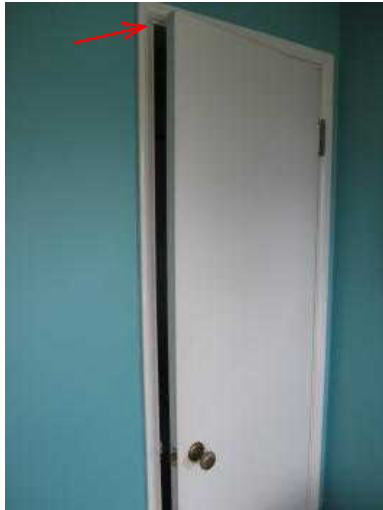
#37 Closet door sticks in jamb.

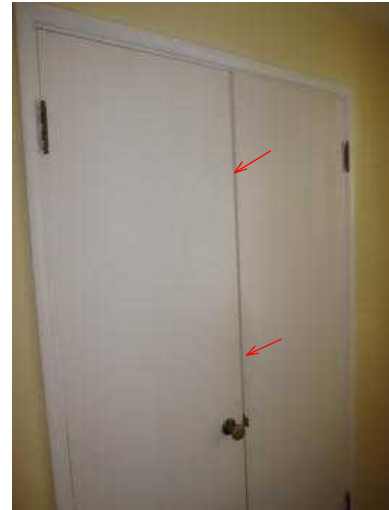
#38 Closet doors stick.

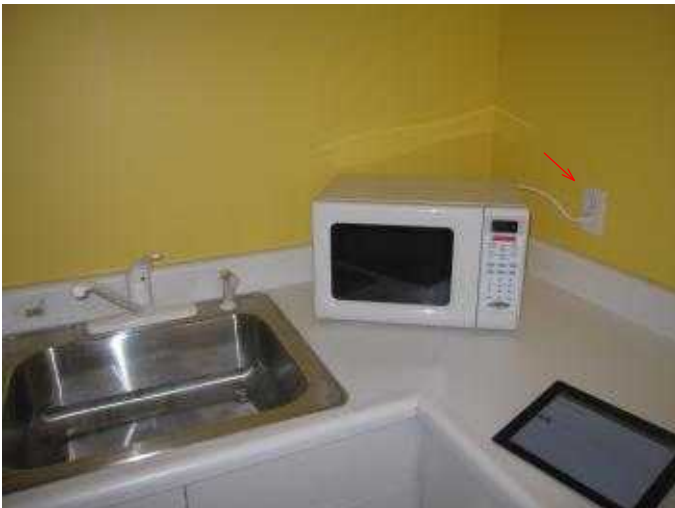
#39 Outlet in utility room should be GFCI protected.

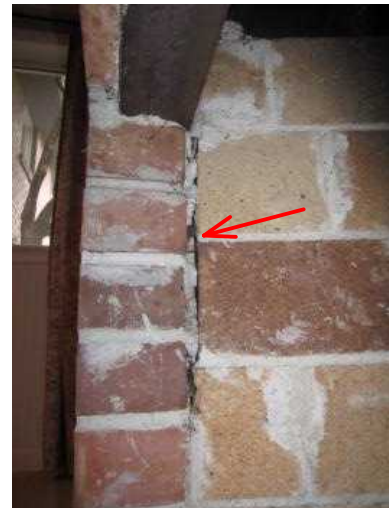
#40 Missing mortar in basement fireplace.

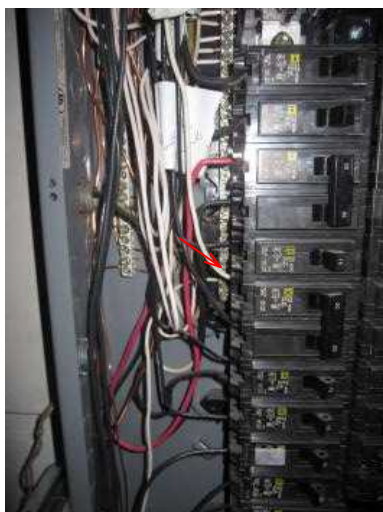
#41 Neutral wire used as hot wire.
